TWR-17639

Space Shuttle Technical Evaluation Motor 3 (TEM-3) Final Test Report

July 1989

Thiokol Corporation
SPACE OPERATIONS

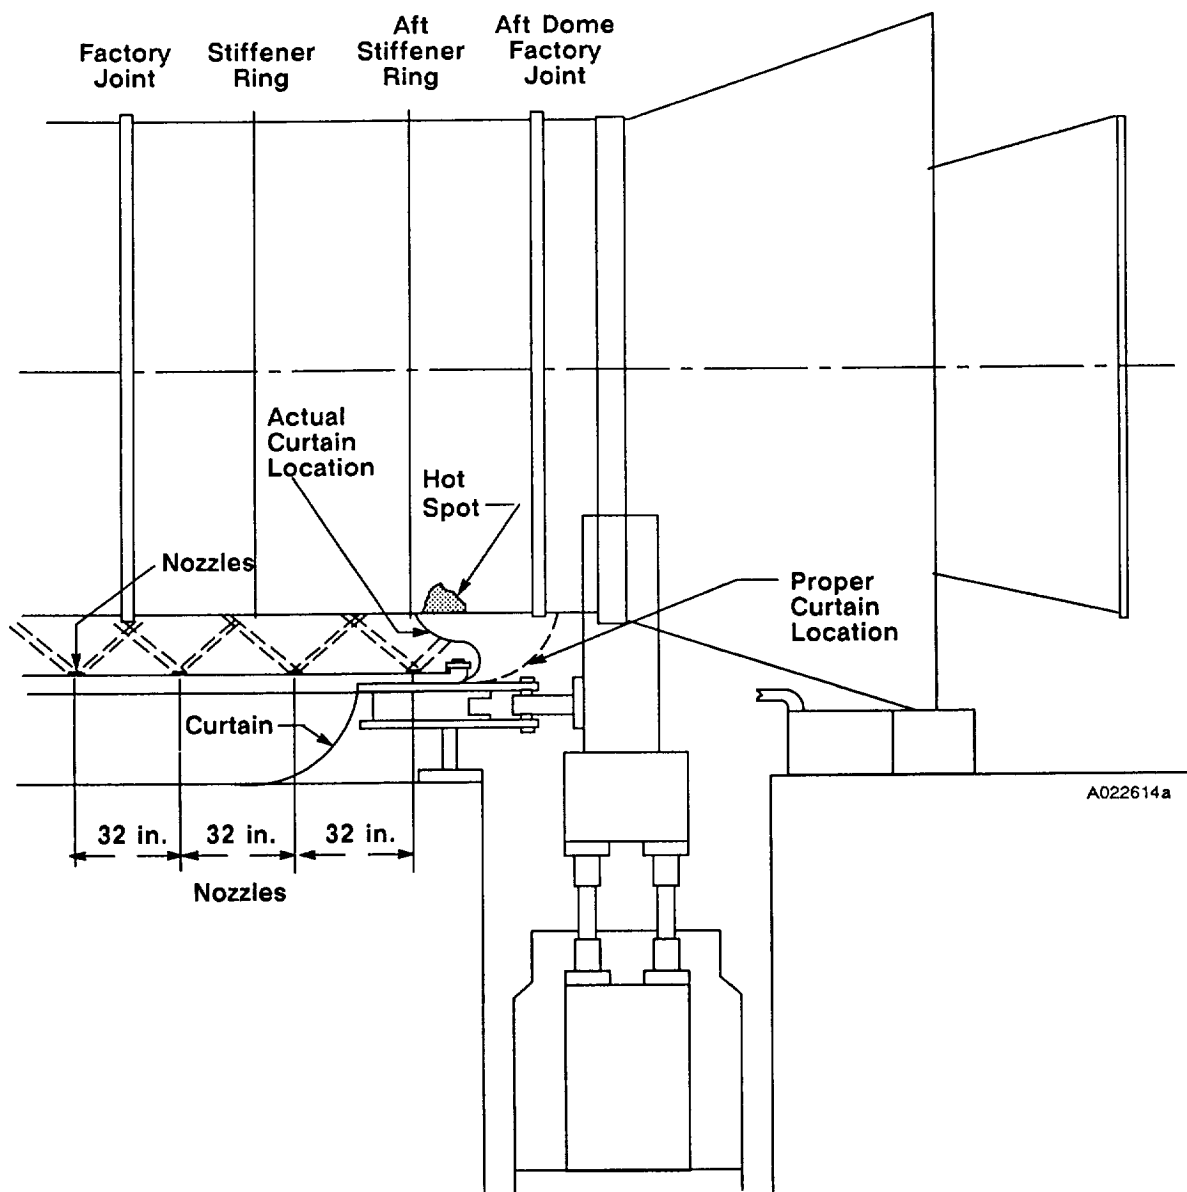
Figure 7.1.3.1-1. Location of Aft Spray Curtain

It was later determined that the spray curtain had been improperly located on the test motor. The spray curtain was designed to be placed beyond the aft dome factory joint, but had been connected to the aft stiffener ring (see Figure 7.1.3.1-1).

7.1.3.1 Motor Deluge System. The deluge spray system was activated at T+105 sec, approximately 18 sec before the end of motor burn. After the motor test, the motor was being sprayed and cooled. During a routine motor walkthrough, it was noticed that an area of discolorization was growing on the motor case in a region shielded from the water spray. The strap holding the spray curtain to the case was cut, allowing the curtain to fall and the spray to cool the discolored area.

Post-test assessment of the motor case showed that the steel case was not affected by the increased temperatures during cooldown.

During the external quick-look inspection, a brown discoloration was observed just aft of the aft stiffener stub. This brown spot was attributed to higher case temperatures due to an above average slag accumulation and the deluge system spray curtain being mislocated. Case hardware was not damaged. Planning has been modified to ensure proper placement of the curtain during future static tests.

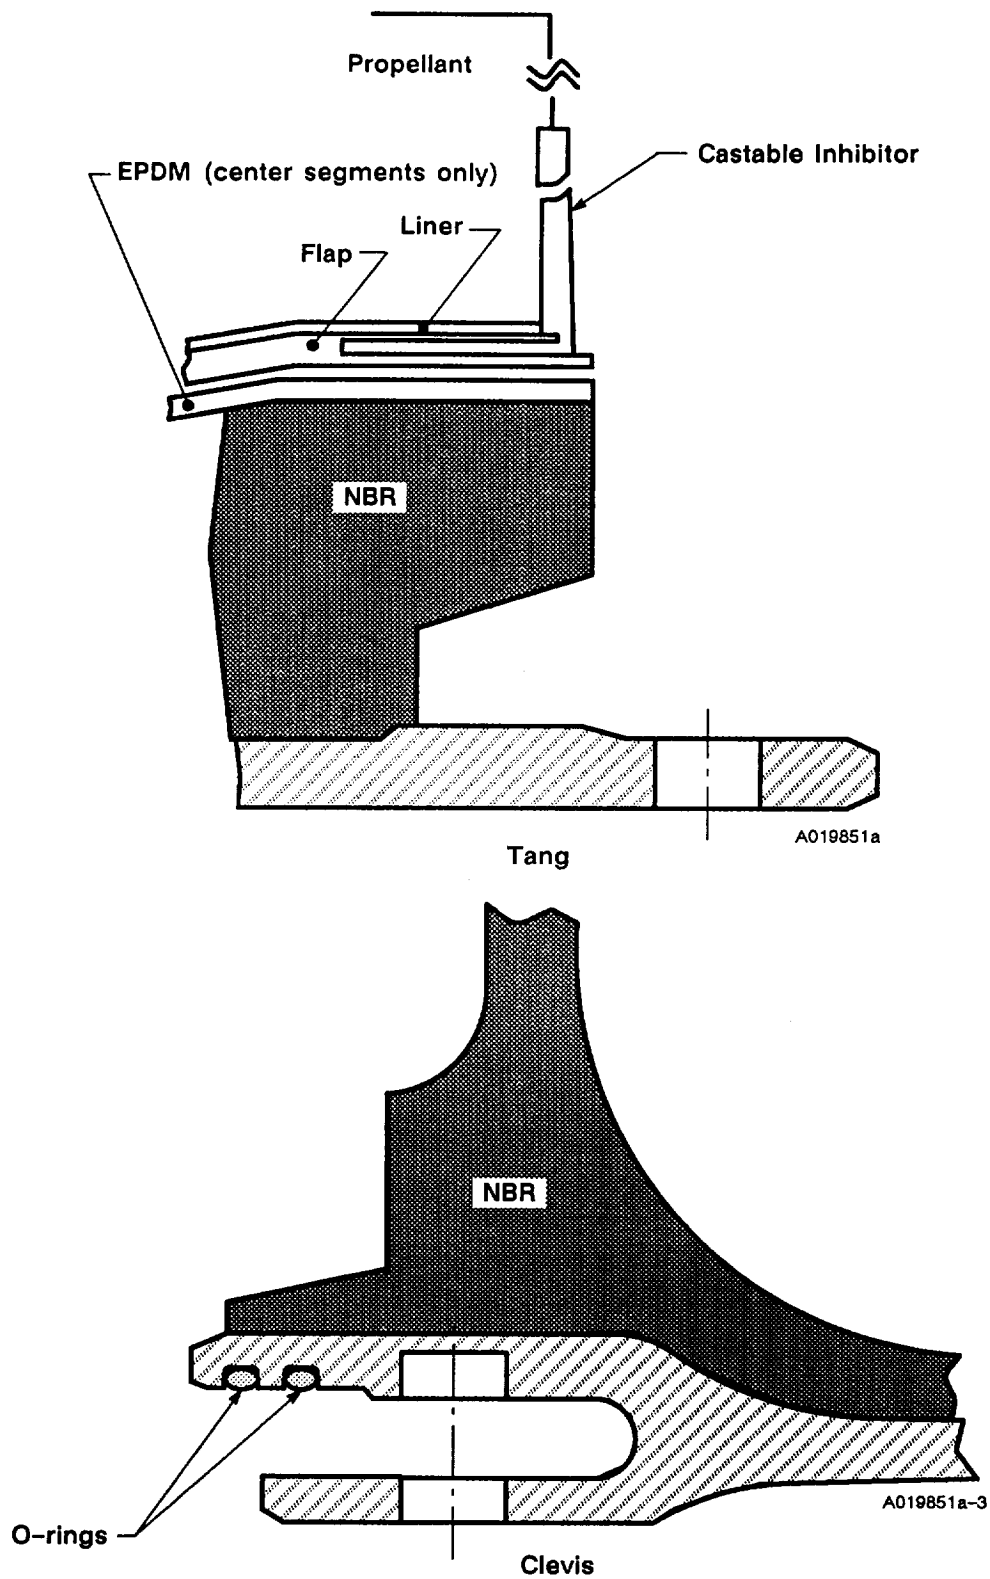
Figure 7.2.1.2-1. HPM Field Joint

Joint filler putty was used in all three field joints. The case-to-nozzle joint used STW4-3266 Canadian Inmont putty. The field joint O-ring seals were not exposed to the motor environment, but there was a small blowhole through the putty in the case-to-nozzle joint.

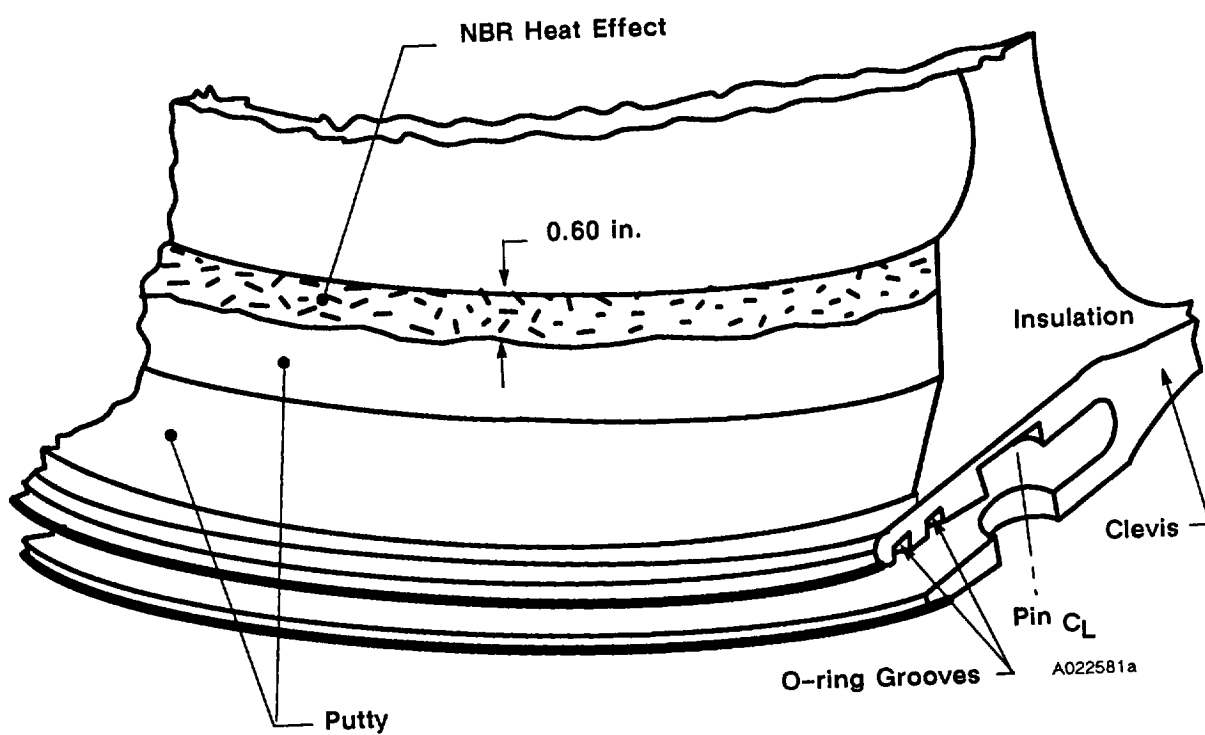
Figure 7.2.4.1-1. Forward Field Joint

At the 132 deg location a terminated gas path flowed radially into the joint to the inboard corner of the ramp surface. It then flowed for a total of 8 in. circumferentially between 129 and 136 deg (Figure 7.2.4.1-2). This gas path appeared to have occurred between the putty and the clevis insulation. The clevis insulation showed heavy heat effects, as the NBR was fibrous and loose at the gas path entry point. Where the gas flowed circumferentially, the NBR had become brown and the Hypalon paint covering the insulation had bubbled. Evidence showed that the gas attempted to flow radially past the inboard corner of the ramp surface at the 133 deg location, but terminated 0.30 in. past this point.

Forward Field Joint. Evidence of hot gas impingement into the forward field joint opening was observed between the clevis insulation and joint putty. At the 132 deg location a terminated gas path flowed radially into the joint up to the inboard corner of the ramp surface. The clevis insulation showed heavy heat effects, as the NBR was fibrous and loose at the gas path entry point. Another soot path was observed at the 180 deg location; it terminated at the inboard corner of the ramp surface. This soot path showed no contact or heat effects on either the tang or clevis insulation.

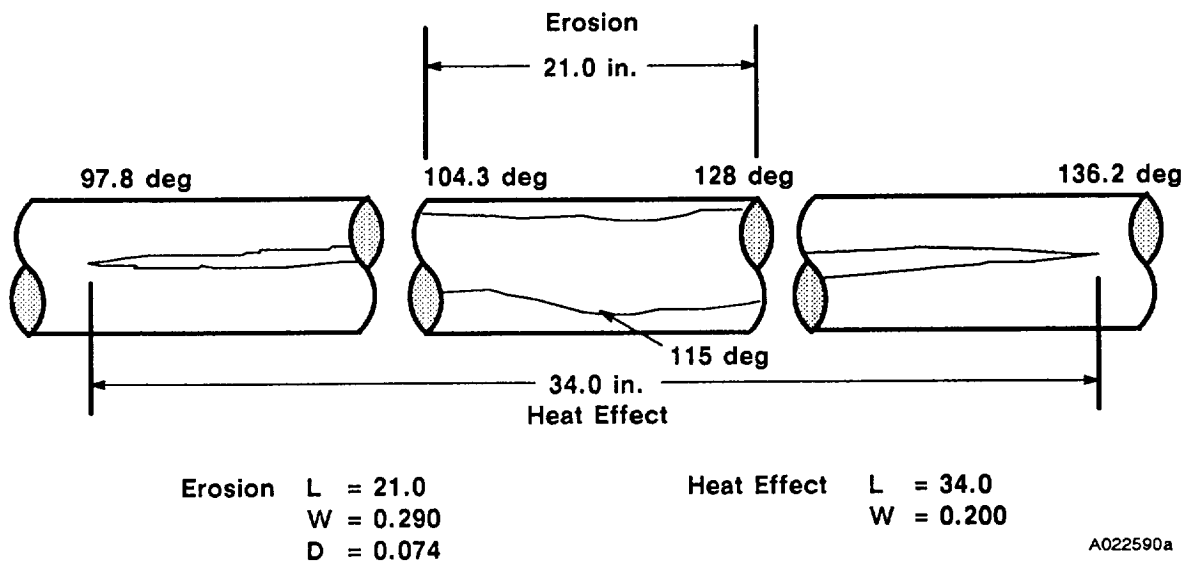
Figure 7.3.4.3-1. Case-to-Nozzle Joint Primary O-ring Erosion

3.1.3.2 Case-to-Nozzle Joint. A 0.4-in. wide putty blowhole which allowed pressurization of the primary O-ring was found at 115 deg. Maximum erosion depth on the primary O-ring was 0.074 inch. No damage was found to the secondary O-ring at the eroded location of the primary O-ring.

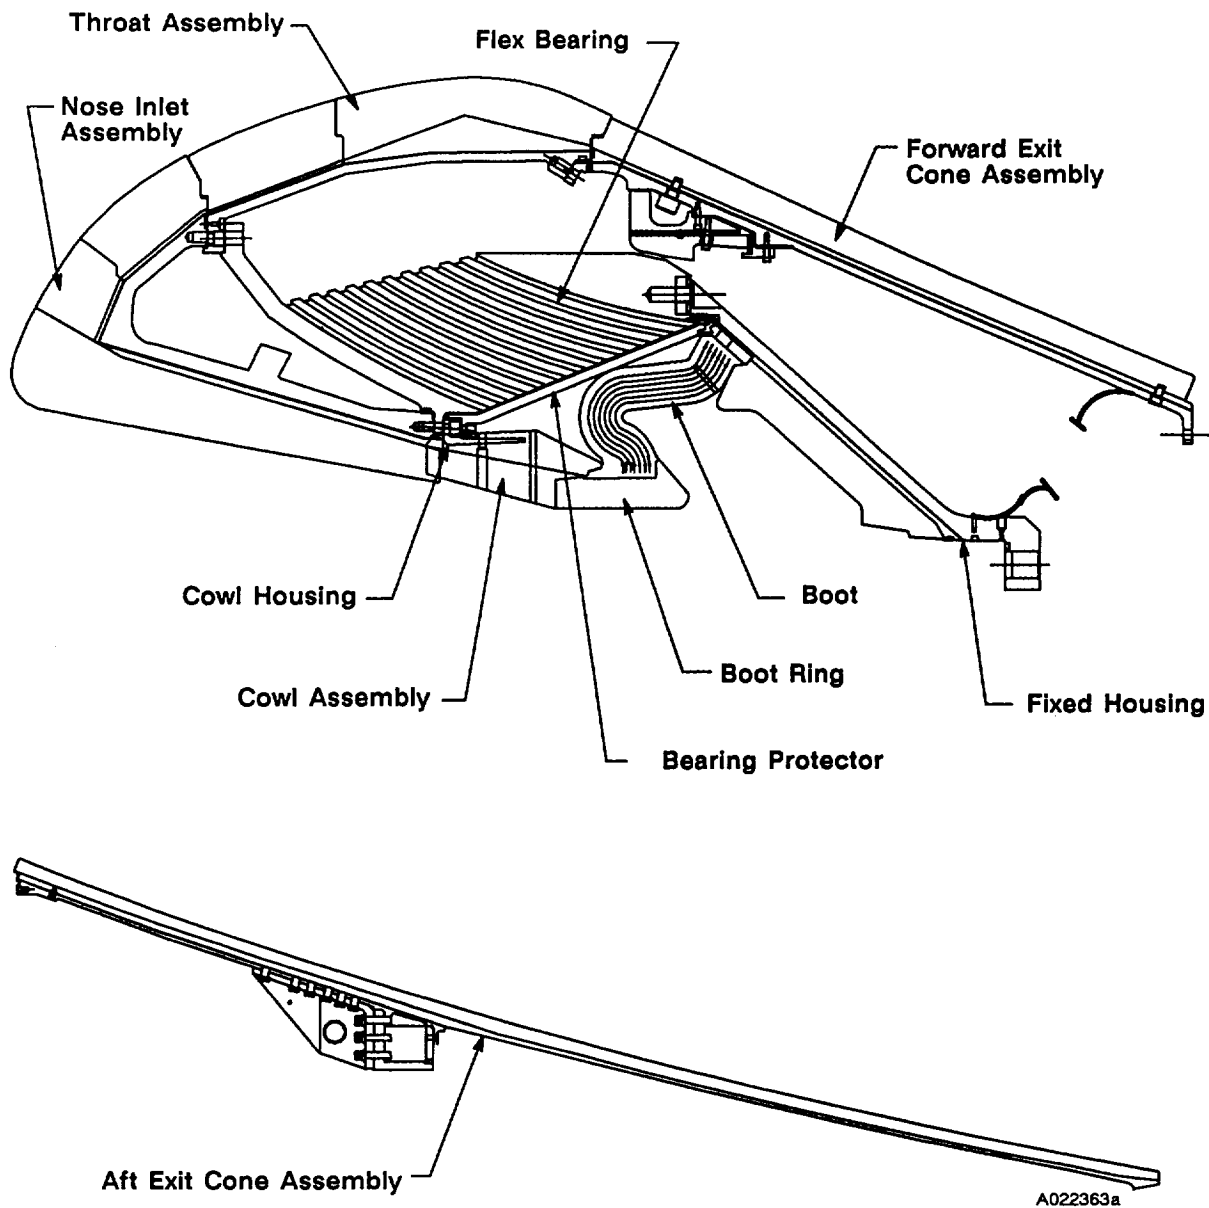
Figure 7.4.1-1. HPM Nozzle

The overall appearance of the TEM-3 nozzle phenolics was good, no abnormal erosion characteristics were observed.

The overall appearance of the TEM-3 nozzle phenolics was good, no abnormal erosion characteristics were observed.

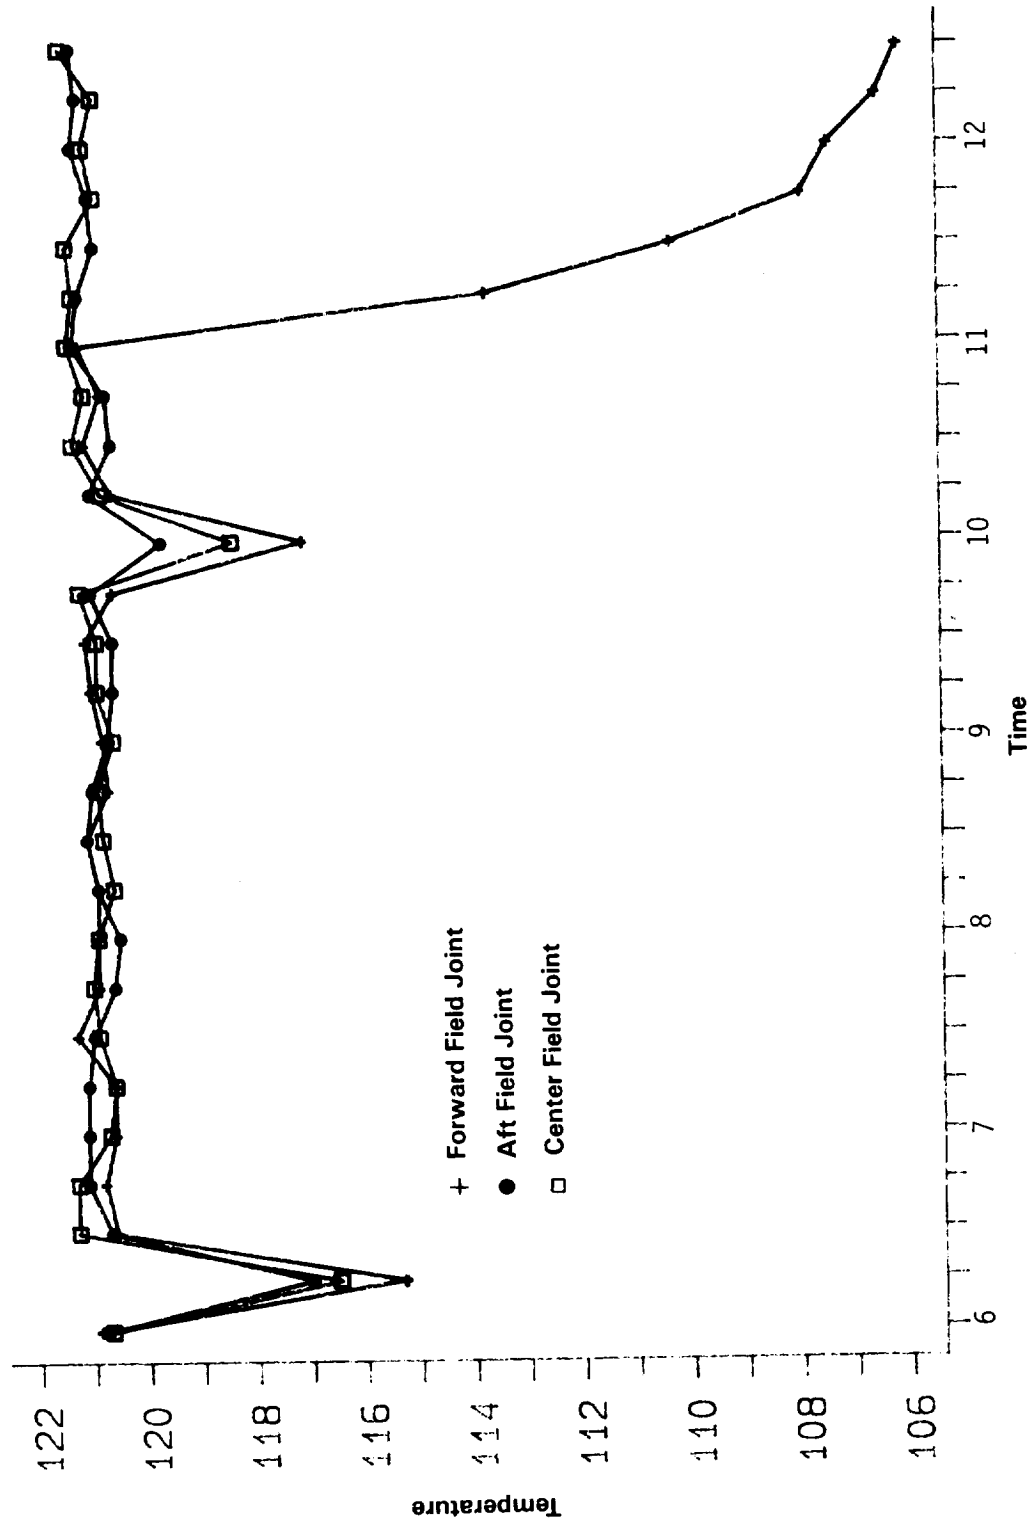
Figure 7.6.4-1. TEM-3 Field Joint Temperature

Field Joint Heater. The heaters on TEM-3 were refurbished heaters. After the test firing, the heaters were operated for approximately 24 additional hours as part of the heater anomaly investigation. After removal from the motor, areas of discoloration were found on the heaters for the full circumference of the joints. Table 7.6.4-4 is the evaluation checkoff worksheet used for the field joint heaters.

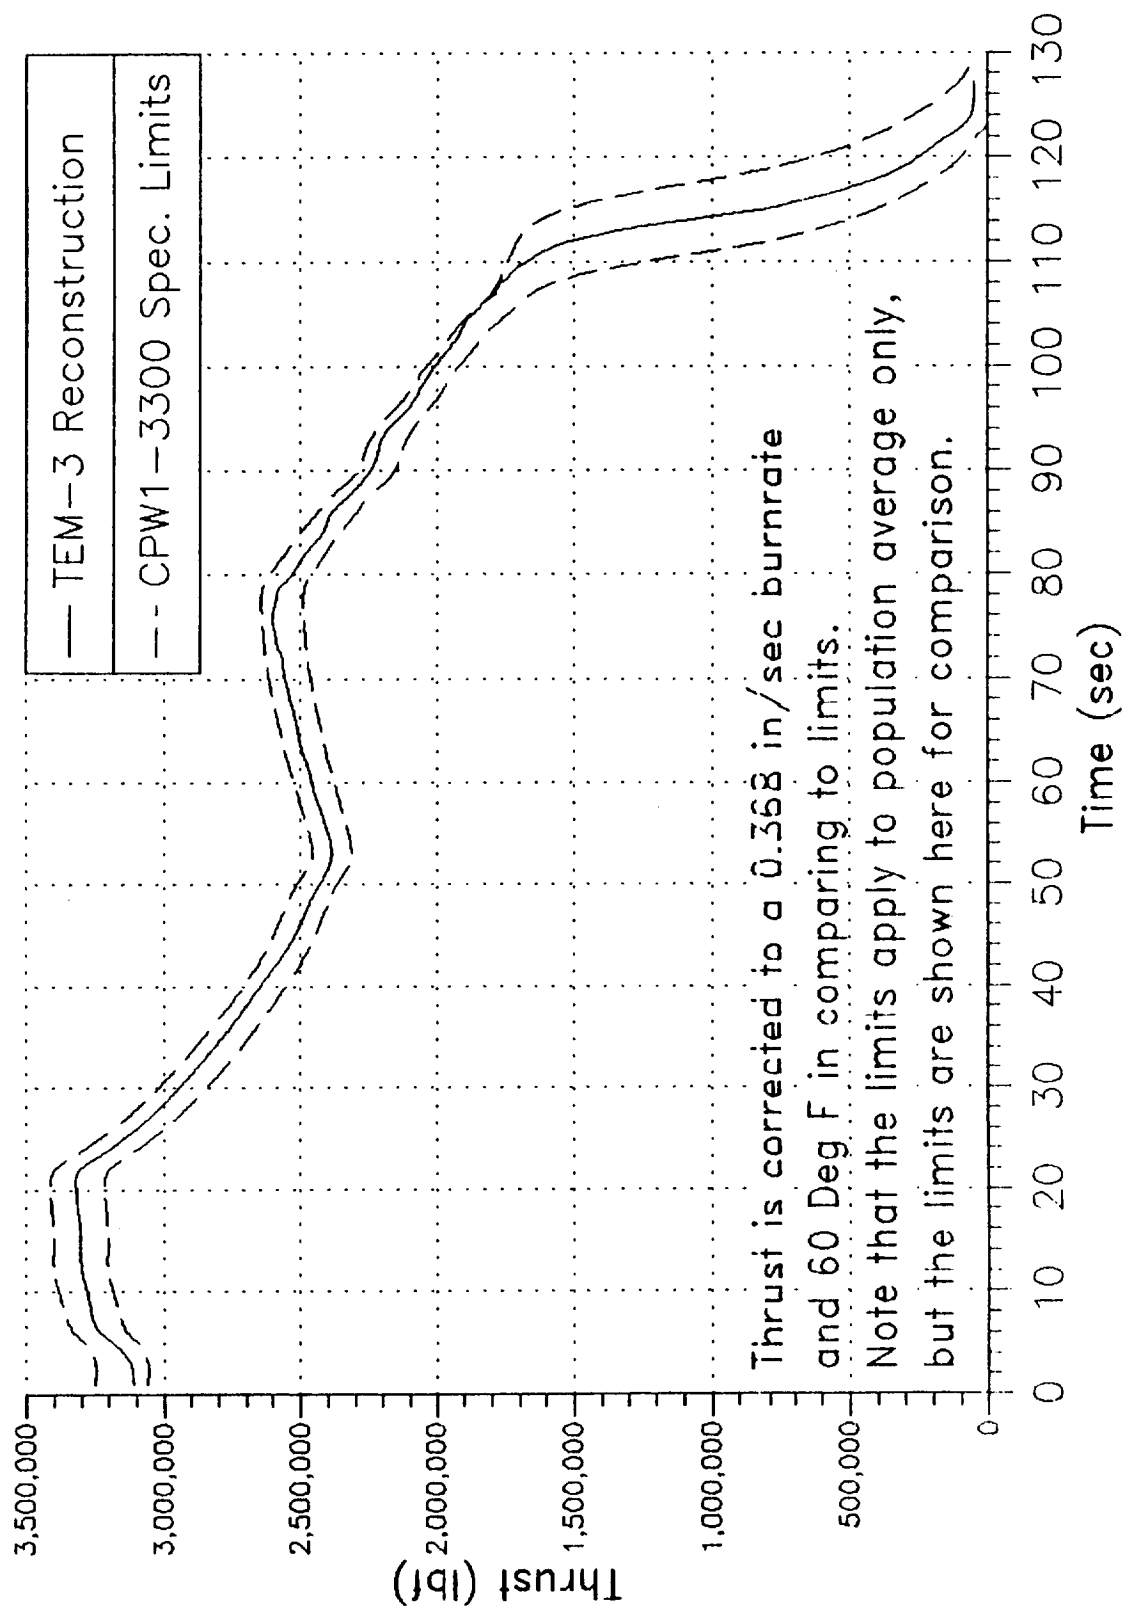
Figure 7.7.4-11. TEM-3 Reconstructed Thrust Compared to CEI Specification Limits

A comparison of TEM-3 reconstructed thrust data, corrected to 60°F and a burn rate of 0.368 in./sec at 625 psia and 60°F with the CEI Specification CPW1-3300, 15 Jan 1986, thrust time limits at 0.368 in./sec, is shown in Figure 7.7.4-11. The TEM-3 performance is within average population limits, except at 106 sec. Note that the limits are for the average of the historical SRM population, not an individual motor. The historical motor population is well within the limits. None of the individual motor performance tolerances and limit parameters were exceeded. The TEM-3 ignition performance satisfied the ignition interval and the maximum pressure rise rate requirements. Both the ignition interval and maximum pressure rise rate were well within the specification limits as shown in Table 7.7.4-4.
